## PERFORMANCE OF SPRAYED POLYURETHANE FOAM ON INDOOR FOUNDATION WALLS

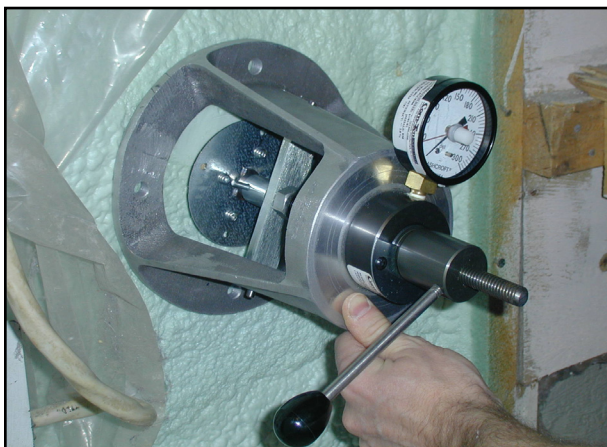
The device used displayed a reading on a dial, expressed in kg, of the tear strength force required to detach the insulation from the foundation wall.

Before the tests, a researcher knocked on all the accessible, insulated wall surfaces to check whether there might be any cavities behind the insulation and to determine the location of the adhesion test sites.
